**DEPARTMENT OF TRANSPORTATION****DIVISION OF ENGINEERING SERVICES**

Contract #: 04-0120F4Cty: SF/ALA Rte: 80 PM: 13.2/13.9File #: 1.28**WELDING INSPECTION REPORT****Resident Engineer:**Siegenthaler, Peter**Address:** 333 Burma Road**City:** Oakland, CA 94607**Report No:** WIR-026244**Date Inspected:** 07-Sep-2011**Project Name:** SAS Superstructure**OSM Arrival Time:** 700**Prime Contractor:** American Bridge/Fluor Enterprises, a JV**OSM Departure Time:** 1730**Contractor:** American Bridge/Fluor Enterprises, a JV**Location:** Job Site

## WELDING INSPECTION REPORT

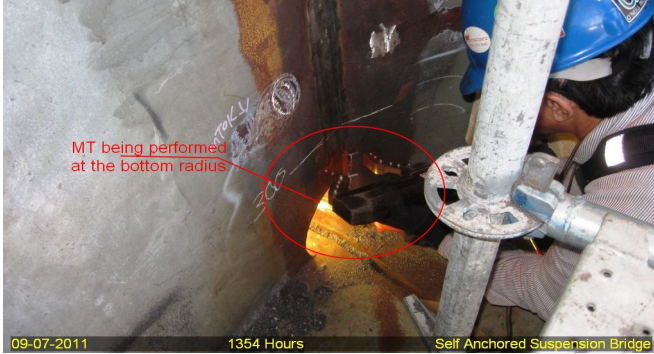
At Tower Base Electro Slag Welding (ESW) T-joint #W-041 location 'W' outside, ABF QC Bernie Docena was observed performing Magnetic Particle Testing (MT) on the bottom radius of the cut and ground slump block removal.

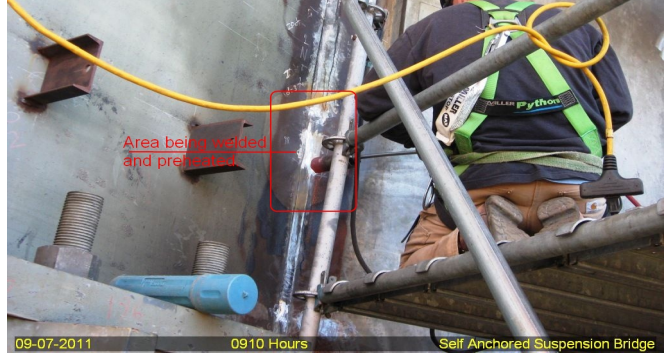
At Tower Base Elevation Electro Slag Welding (ESW) T-joint N-041 location 'N' (outside), QA randomly ABF welder Jeremy Dolman continuing to perform 3G SMAW cover welding repair due to excessive grinding. The welder was observed welding in the 3G (vertical) position utilizing Shielded Metal Arc Welding (SMAW) with 1/8" diameter E7018H4R electrode implementing welding procedure ABF-WPS-D15-1000-Repair Rev. 2. The repairs at various locations were having a depth range of 3mm to 6mm. The excavations were previously tested using Magnetic Particle Testing (MT) by ABF QC Steve Mc Connell and verified by this QA with positive result. The repair excavations and the adjacent base metal were preheated to more than 300°F using the propylene gas torch. During the shift, ABF QC John Pagliero was noted monitoring the welder. Measured welding parameter during welding was 110 amperes on a 1/8" diameter E7018H4R electrode. During the shift, repair welding was completed and the welder has moved to another ESW location 'W' inside.

At Tower Base Electro Slag Welding (ESW) T-joint #N-041 location 'N' outside, ABF welder Jeremy Dolman was noted preheating the area being welded and its adjacent weld metal prior to repair welding the ESW weld cover.
